## CHALLENGES IN THE CONSERVATION OF AN EARLY 19<sup>th</sup> CENTURY HOLY DOOR - THE FIRST STEPS

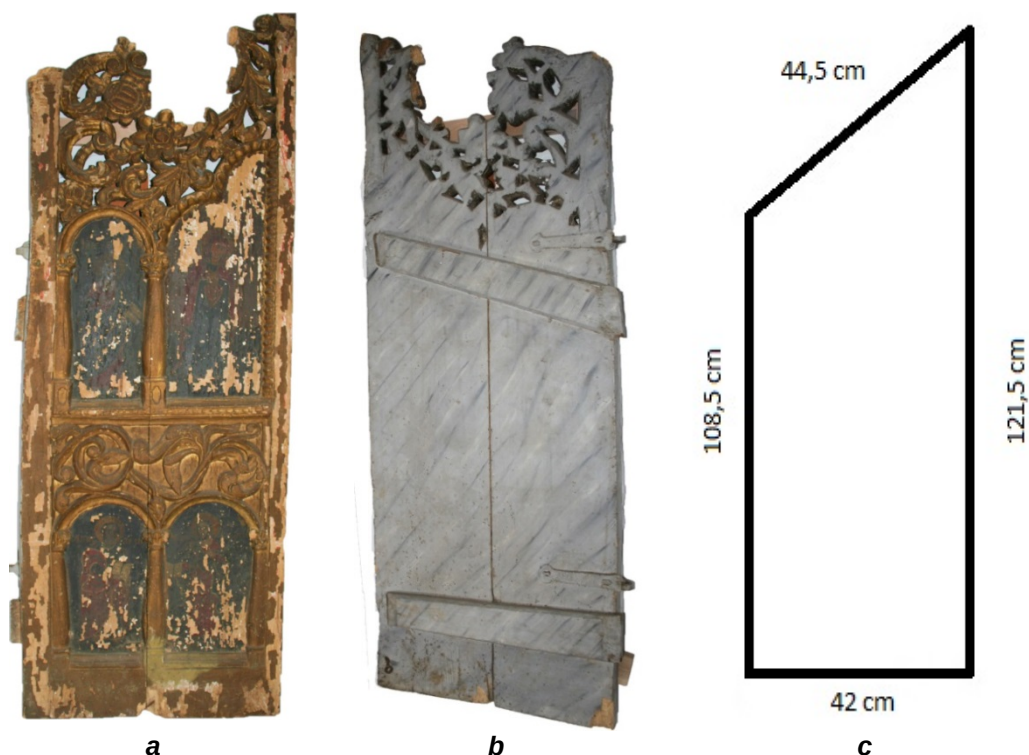
Fig. 1.

*The Holy door- general aspect and structure: a) face view; b) back view; c) dimensions.*

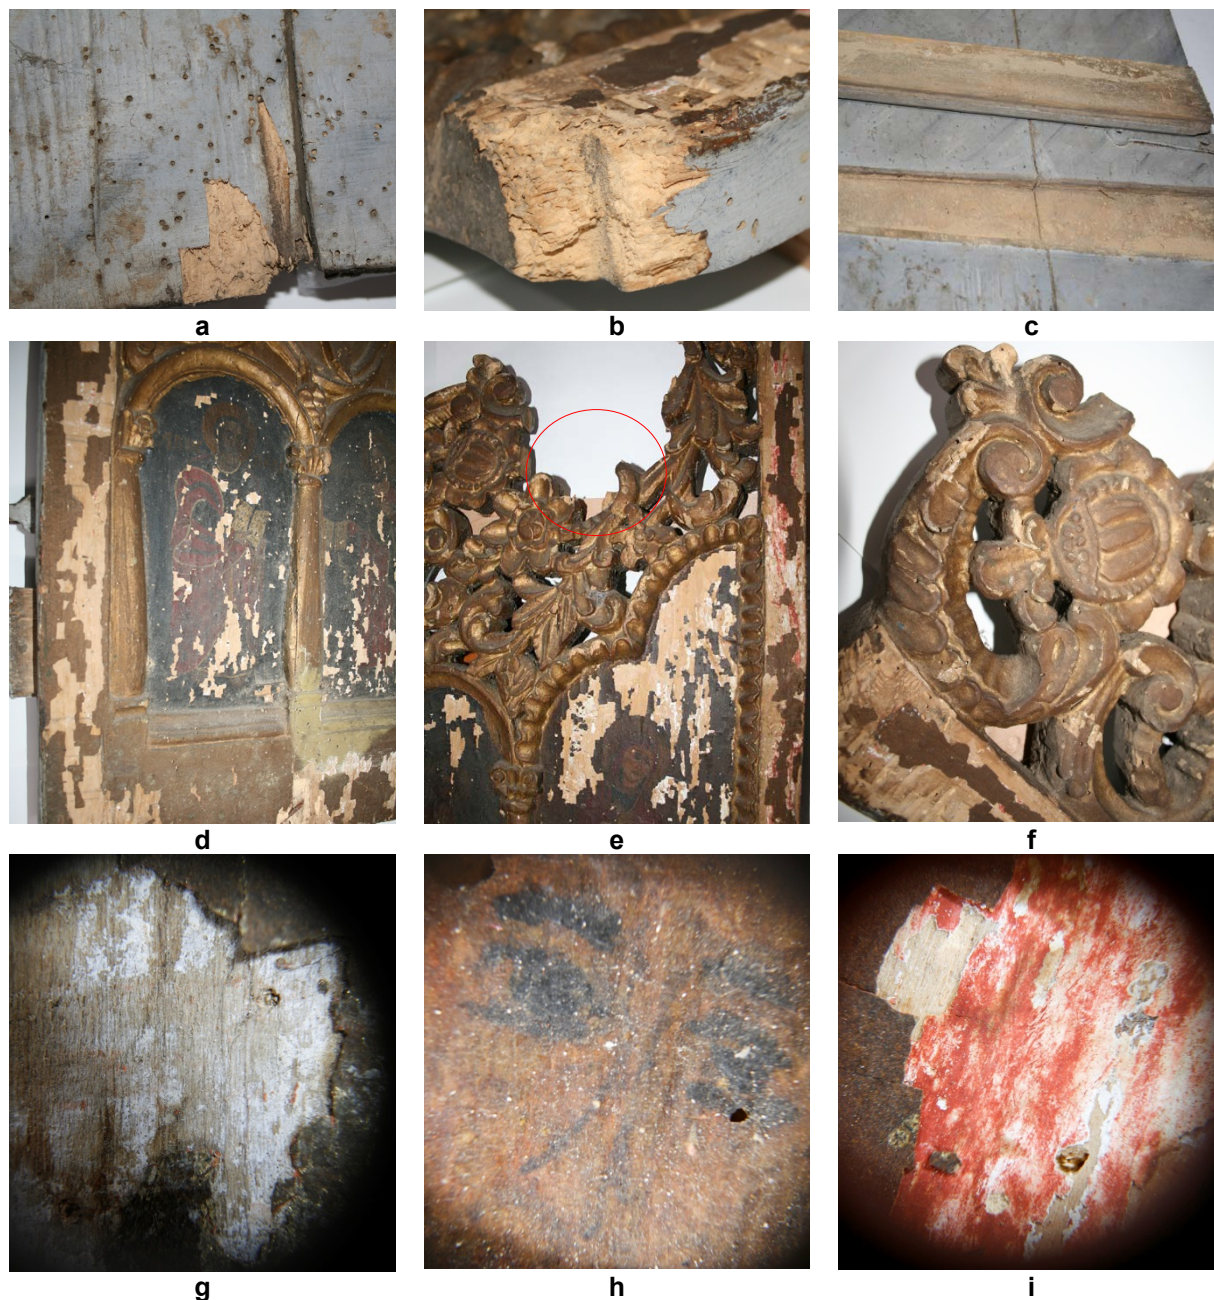
**Fig. 2.**

Due to the ageing of materials and totally inappropriate conditions the object was deposited and totally neglected for a very long period of time (at least 80 years), the initial conservation state of the holy door (Fig.1a, Fig.2), was very unstable and precarious for both the wood substrate and the painting layer, imposing urgent conservation actions. Severe insects attack, still active in some areas, caused advanced wood frailness, so that ruptures with loss of material occurred (Fig. 2 a,b,c,e).

The painting layer for the four icons was extremely dark, fragile, crackled, non-adherent, with extensive flaking, explaining the significant losses as lacunar or more compact areas (Fig.1a, Fig. 2 d,e). An approximation of losses of the original painting layer conducted to the following values: 15% for I1, 40-45% for I2 (with almost total loss of the background painting layer in the upper part), 20% for I3 and 25% for I4. The risk of detachment and further losses were maximum, with irremediable bad consequences on the value and authenticity of the object. Accordingly, consolidation of the still existing but very aged and fragile painting layer, to ensure its preservation without any further loss, was a major challenge and the first step in the conservation process, as described later in this paper.

The "gilded" area, very dirty and darkened, of brownish colour, was also affected in terms of integrity and adherence to the substrate (Fig. 2 d,e,f). Areas of total exfoliation up to the bare wood (Fig. 2 g) alternated with areas of delamination between the top layer and the white preparation layer, while in some areas the red bolus was still visible (Fig. 2 i). Maximum losses occurred on the "frame" (the rectangular side and bottom parts) of the assembly, being approximated at about 50% on the left stile, 70% on the right stile and almost 50% on the bottom rail. Some trends of exfoliation of the "gilding" were also present in the sculptured upper part of the door leaf, as well as evidence of previous "consolidation" by overpainting with a bronze varnish, with contrary results. Frailness of wood and the lacy sculptured structure of this highly decorated area caused unfortunately rupture with loss of material, approximated to about 20% from this area. Unfortunately, completion of this sculptured missing part will not be possible due to the lack of relevant information (similar elements).

*Details of the initial state of conservation: a) insects attack; b) fragile wood and rupture; c) massive active insects attack; d,e,f) details of degradation of “gilding” and painting layer with significant losses; g) magnified view of lacunar loss of gilding layer up to the wood substrate; h) detail of aged painting layer through magnifying glass; i) magnified view of lacunar loss of gilding – white gesso and red bolus still present.*

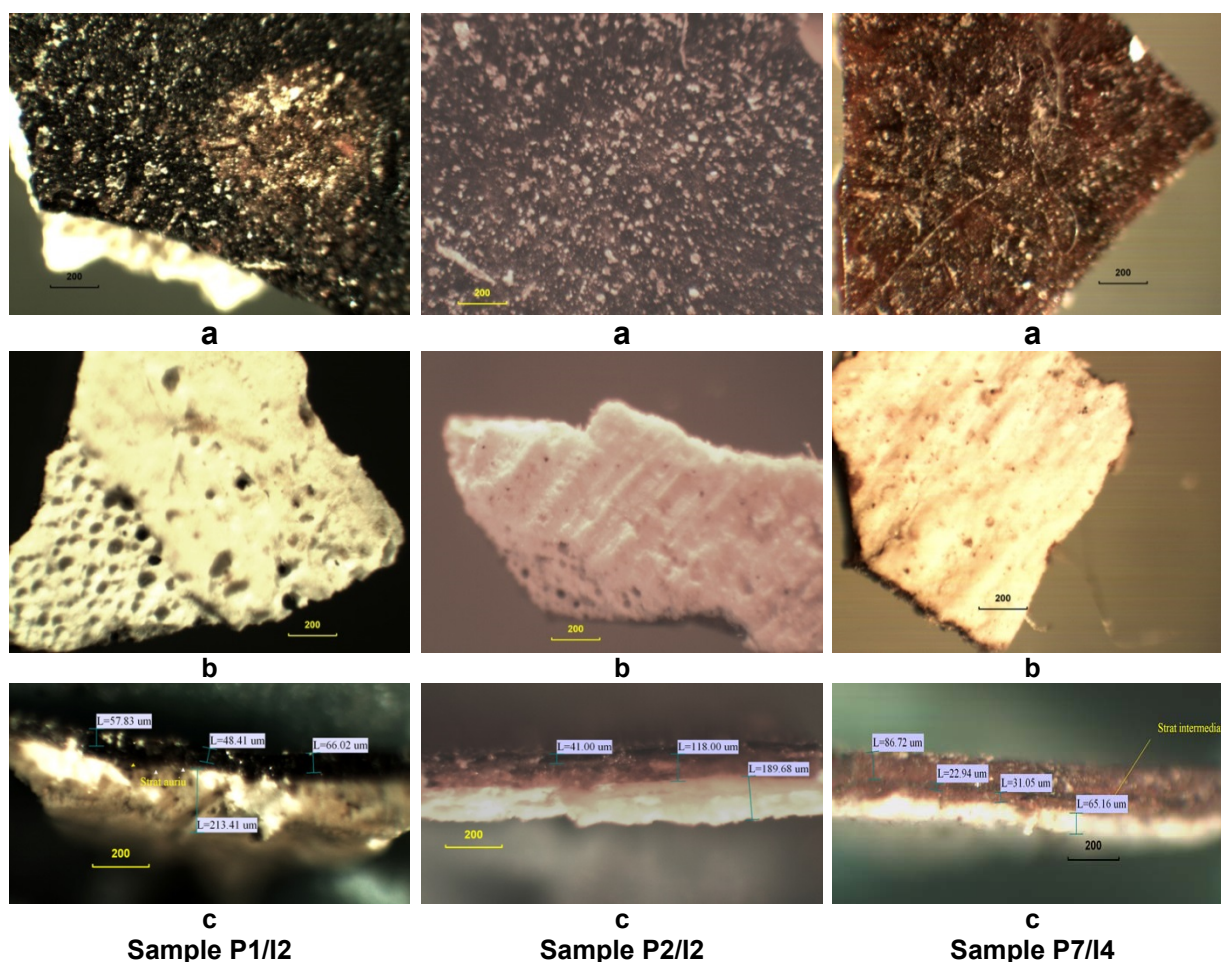
Fig. 4.

*Microscopic structure of the painting layer - exemplification for samples P1, P2 from icon I2 and P7 from icon I4, observed under stereomicroscope at 60x magnification: a) face - top layer, b) back-preparation layer, c) cross-section.*

The microscopic investigation of the paint layer samples (Fig. 4) clearly revealed that the wood substrate was prepared by application of a white base coat of "gesso" type. The total thickness of this layer varied from about 100 $\mu$ m to about 200 $\mu$ m and appears to have resulted from successive application of materials with different porosity. Also the topography of the layer in direct contact with the wood substrate seems to indicate processing of wood to ensure a better adhesion of the ground layer, a usual technique for

For all the samples, a dark top layer, with granular structure and different inclusions (e.g. fibrous filaments) was observed. This might be a top varnish which entrapped smoke, charcoal particles and dust. Several other layers, of different colours depending on the sample origin, were observed in the cross-section. For some samples, a very thin and discontinuous, yellow, highly reflective layer was observed, which might indicate application of a gold/metal leaf prior painting in order to endure a special luminosity and colour effects. (Gettens and Stout 2012).

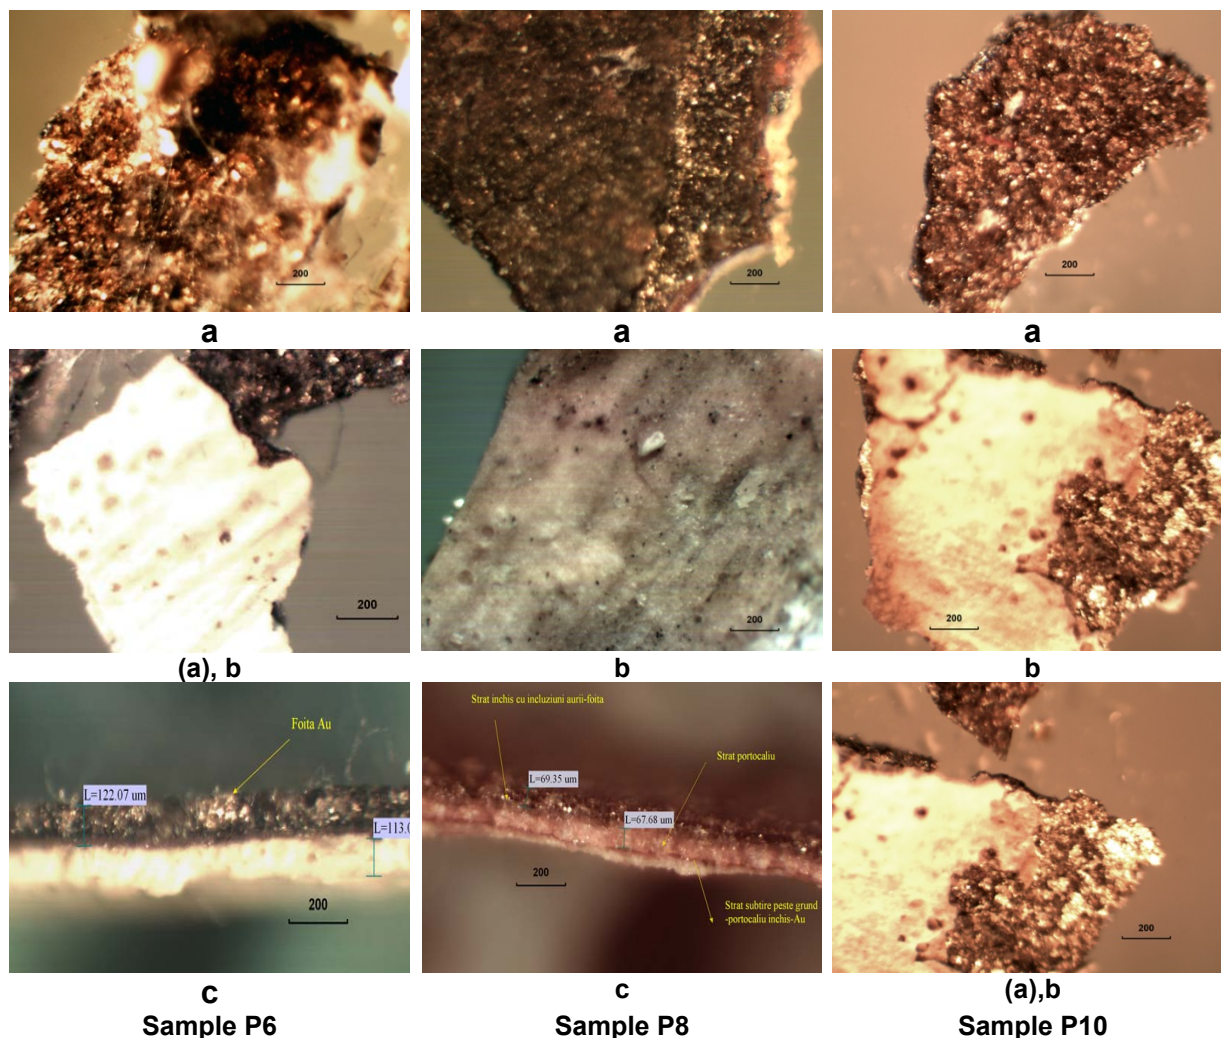
Fig. 5.

**Microscopic structure of the "gilding" layer - exemplification for samples P6 (moulded arch I4), P8 (bottom part of the "frame"), P10 (floral ornaments from the top), observed under stereomicroscope at 60x magnification: a) face - top layer, b) back-preparation layer, c) cross-section.**

The microscopic investigation of the "gilding" samples (Fig. 5) revealed that the wood substrate was prepared by application of a white base coat of "gesso" type, similarly to the painted areas. FTIR investigation of the preparation layer (not presented in this paper) indicated that this was prepared from animal glue (possibly rabbit skin glue) and chalk, though XRF analysis revealed also presence of lead (Pb) alongside calcium (Ca) in the gesso. For some gilded areas the application of a red "bolus" on top of the white gesso was evident microscopically. As the actual "gilding" material is concerned, two main aspects were revealed: 1) the non-uniform, granular aspect of the surface, with yellowish shiny areas alternating with darker spots; 2) discontinuity of the gilding material in the cross-section, with only isolated areas indicating the potential presence of a metallic/gold leaf. These support the assumption of an advanced degradation of the original gilding with metallic leaf and re-painting with a varnish containing metallic powders.

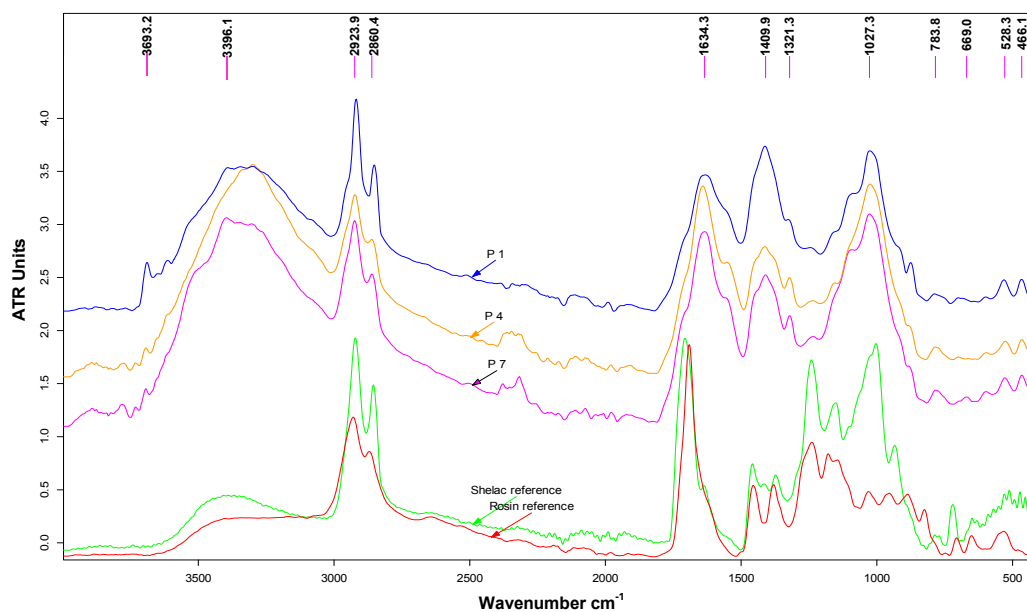
**Fig. 6.**  
**FTIR spectra of the surface of painting samples – top layer.**

The FTIR investigation of the surface of the samples of painting layer (Fig.6) indicates that very likely a varnish containing shellac and rosin, alongside other components, has been applied to protect the tempera painting.

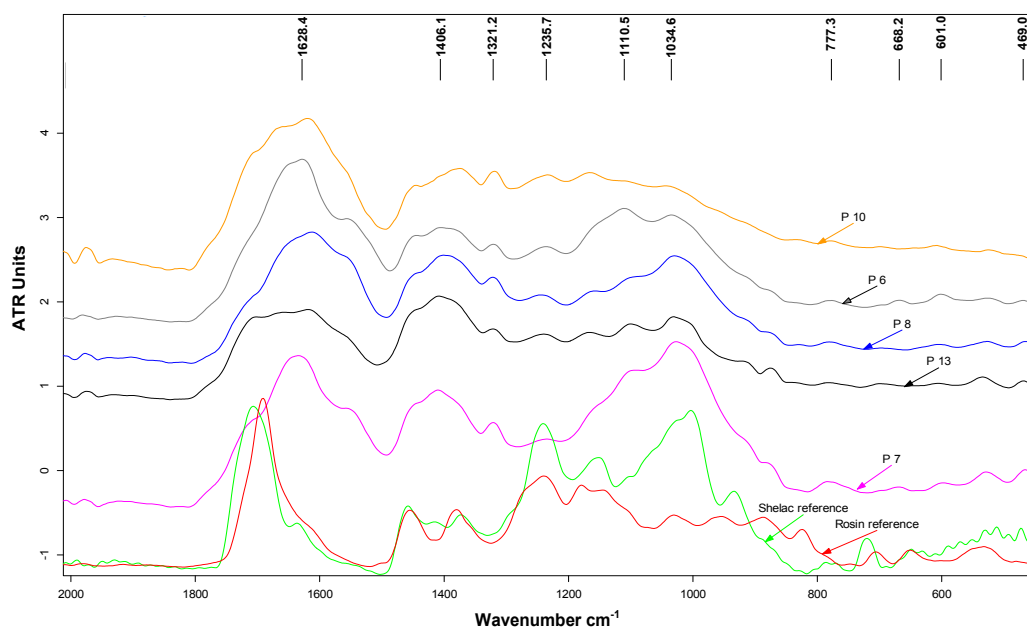
**Fig. 7.**  
**FTIR spectra of the surface of gilding samples – top layer (P6, P8, P10, P13) compared to.**

The FTIR spectra registered for the surfaces of the “gilding” samples (Fig.7) indicate a slightly different type of varnish than that applied on painted areas, though it is possible that the same varnish was applied on top of a “gilding” varnish (containing metallic powder) employed to “restore” the original gilding. More tests and complementary methods are needed to clarify these aspects.

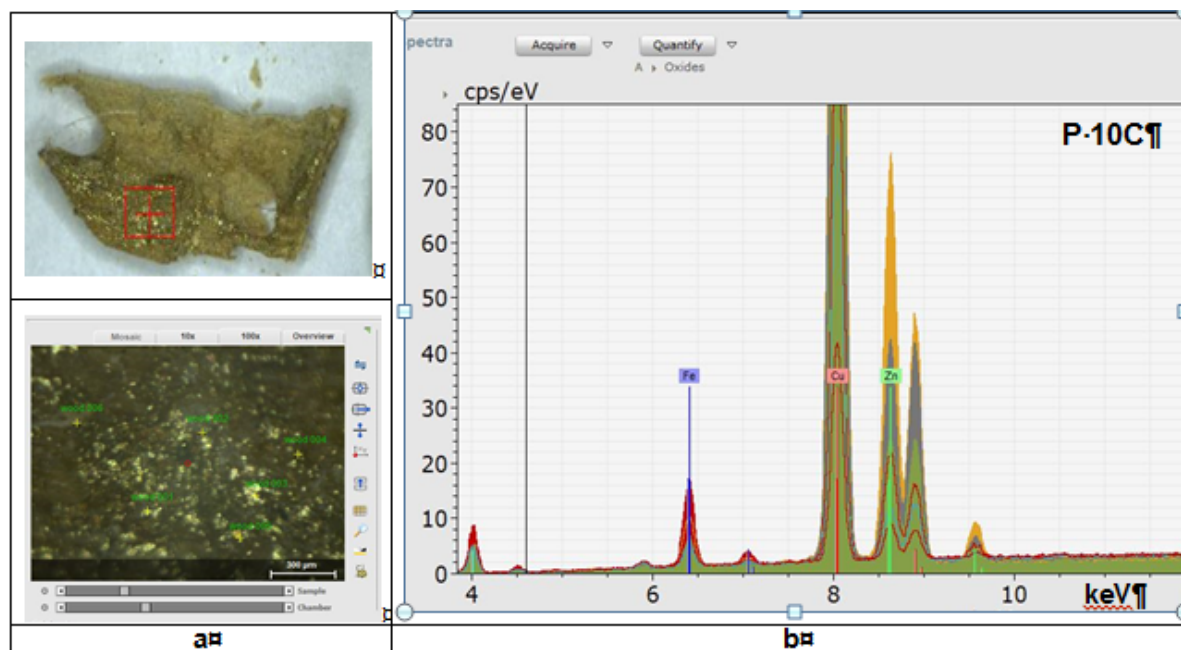
**Fig. 8.**  
**Micro-XRF analysis of sample P10-gilding- floral area.**

XRF and micro-XRF (Fig.8) analyses were employed in an attempt to elucidate the nature of the “gilding” material. These tests were performed on samples collected after cleaning, actually controlled partial stripping the gilded surfaces with a solvent based diluted stripping solution. The main metallic elements found were copper (Cu) and zinc (Zn), no gold (Au), which indicates a brass alloy. The same metals were identified on the cotton swabs employed for cleaning, which indicates that cleaning should go deeper in order to get to the original gilding. However, this might be risky, as very likely the original gilding layer might have been lost in high proportion, explaining massive repainting. Therefore, any further steps will be agreed with the legal owner of the artefact (the museum’s curator). It has to be mentioned that not only gold leaf, but also brass, bronze and silver leaves were employed in 18<sup>th</sup> and early 19<sup>th</sup> century for such artefacts (Angold 2014)

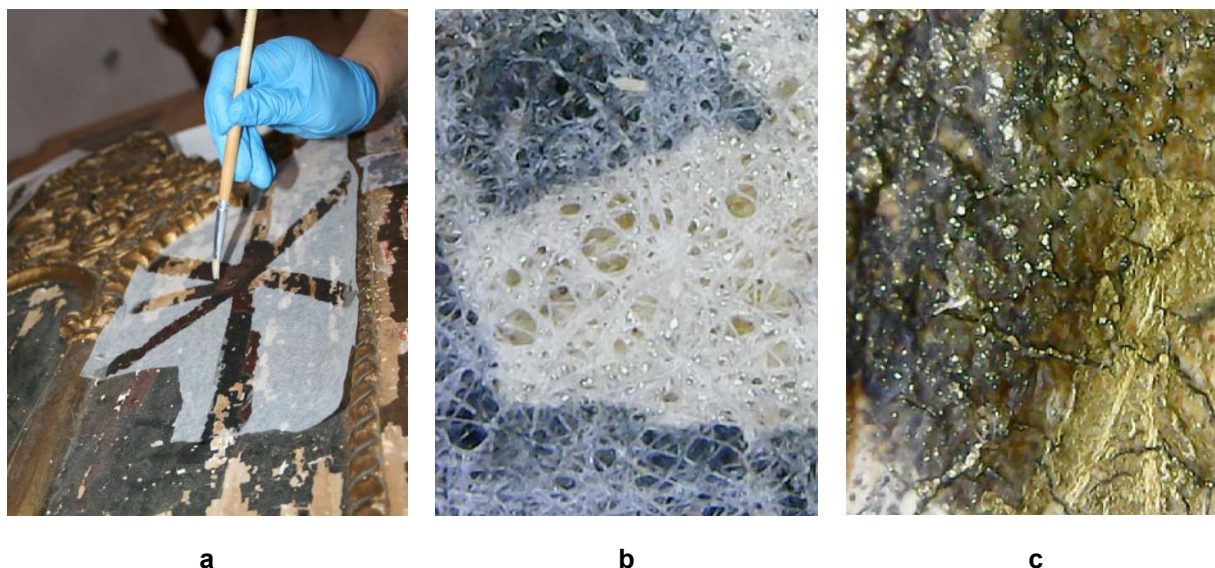
**Fig. 9.**

**Aspects of conservation and consolidation of the original painting layer and gilding: a) application of the Japanese paper; b) macroscopic aspect of a consolidated area of painting layer- fibres of consolidating paper c) final aspect of a gilded consolidated area after removing the Japanese paper – edges of a gold/metallic leaf evident on the right side.**

The concept of conservation considered with priority active conservation methods with a view of ensuring preservation of the object authenticity, meaning no further loss of painting and “gilding. Accordingly, the first step was consolidation of the very frail original painting layer and flaking “gilding” areas employing Japanese paper and diluted fish glue solution (Fig.9), the application of the protective material being followed by hot pressing (at 60°C) with electric spatula, or alternation of hot and cold pressing, by case. Once this goal was reached, it followed the active conservation of the wood substrate in order to stop the active insects attack and consolidate the frail wood. For this purpose an insecticide solution (Perxil 10) and then Paraloid B72 (solutions 5%, 7% in ethyl acetate) were applied by injecting into the insects galleries in several reprises. At this stage, structural repairs as completion of small missing parts and consolidation of the panel structure were possible. The steps to follow are those of thorough cleaning of the surfaces, based on previous testing of different solutions for the different types of surfaces (icons painting, gilding, marble-like paint on the back of the door). A standard solution (based on water, alcohol and non-ionic detergent) was adequate for the back of the door, whilst totally un-effective for the “gilded” parts, for which a diluted stripping solution (Chromofag / Ethyl alcohol in ratio of 2:1) was employed. The cleaning of gilding is still in progress. Preliminary tests indicated that the painted areas (icons) can be adequately cleaned with ethyl alcohol 97%.
