## A RUSTIC MIRROR FRAME - AN IN-DEPTH INSIGHT INTO THE METHODS AND CHALLENGES OF THE RESTORATION PROCESS

### Abstract:

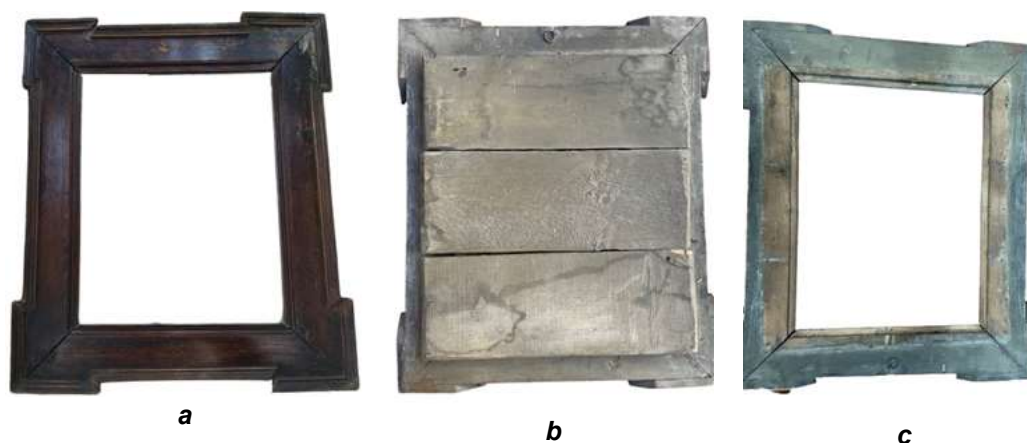
Fig. 1.

The object is a rustic mirror frame, originating from Schei, Braşov. It was manufactured at the beginning of the 20th century. The frame is made from spruce wood (*Picea abies*), with mitre joints at 45° (Figure 1). On the back side, three longitudinal panels, roughly processed, fixed the mirror (Figure 1b). Profiled hardwood strips are applied to the frame contour on the front side. These create an oversized effect on the corners and have a decorative outcome (Figure 1a).

Initial state of the mirror frame – a-front face, b-back panels for mirror fixing, c- back side.

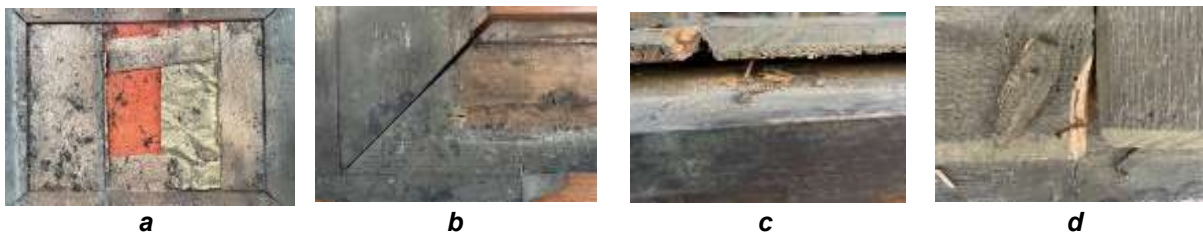
Fig. 2.

The conservation state of the frame indicates that it has been relatively well maintained. However, signs of major xylophagous attack are evident over the entire surface of the frame, with a lot of galleries and wood dust, especially on the back side. When the back panels were dismantled, an extremely dirty area was found between the panels and the mirror (Figure 2a). The mitre joints have become spaced because of the dimensional changes of the wooden material due to the humidity fluctuations (Figure 2b). Additionally, the inappropriate fastening of the back panels with nails led to rust and the breaking of the material. (Figure 2. c, d)

**Initial defects on the back sides of the frame: a – dust deposits on the back of the mirror; b- displaced joints and insect attack; c and d- wood detachments and nail damage.**

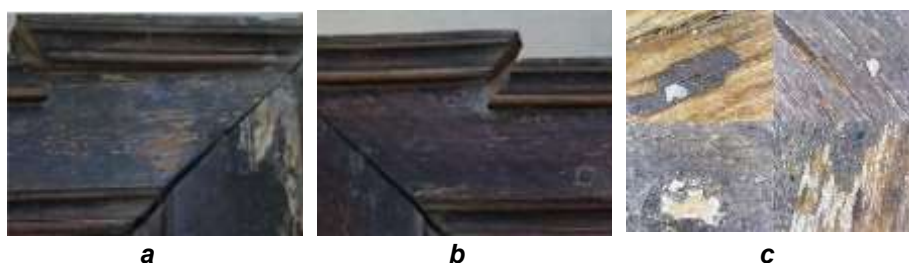
Fig. 3.

On the front of the painting, there were noticeable detachments in the paint layers, especially in the lower part of the frame. The most affected areas are the corners, which have visible gaps in the joints (see Figure 3a). This damage may have resulted from the storage and usage conditions of the object. Additionally, the finish layer has visibly darkened over time. Some decorative strips along the frame's outline are also missing (Figure 3b). Figure 3c presents a magnified image taken under an optical microscope, revealing the lacunar areas in the finish layer. This indicates the stratigraphy of the painting, showing a white gesso layer beneath a brown layer that imitates wood grain.

**Initial defects on the front sides of the frame: a- lacunar areas in the painted surface and an unattractive brownish finish; b- missing decorative elements; c- painting layers magnified by a digital microscope.**

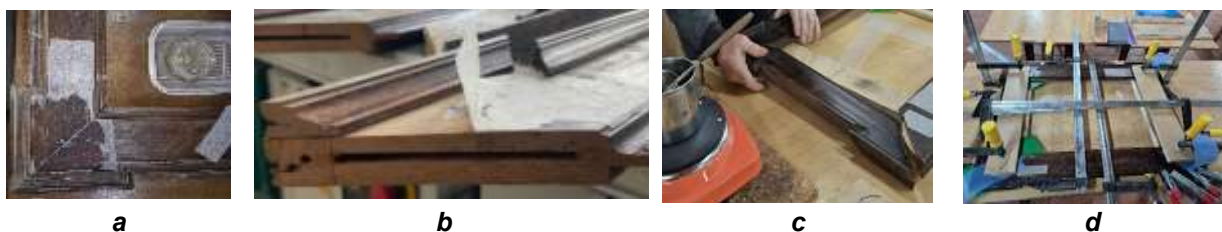
Fig. 5.

**Operations from restoration of the frame: a - painting consolidation; b- processing of mortise; c,d- assembling and clamping the frame.**

Dry cleaning was performed on all wooden components with soft natural-bristle brushes. This intervention removed superficial contaminants accumulated over decades. Subsequently, consolidation of the degraded paint layer was carried out by the application of Japanese paper as a temporary protection layer to prevent further losses during the next procedures (Figure 5a).

Since the finishing layer has been stabilized and protected, wet cleaning was possible. A standard cleaning solution was applied to the backside using brushes and cotton wipes, combining solvent action with gentle mechanical cleaning. An essential step involved a curative treatment against insects. This was done by injecting a Bochemit solution diluted in ethyl alcohol, ensuring deep penetration into the wood structure.

The wooden joints required complete structural intervention. The four elements of the frame were separated, and defects in the alignment and precision of the 45-degree joints were identified. These imperfections compromised both the structure and the aesthetics of the frame. Each element was re-cut at the ends to correct the joining planes by removing deformed or misaligned material. This geometric recalibration ensured perfectly flat contact surfaces and an accurate 45-degree angle, which is essential for achieving tight, aligned joints (Figure 5b). New mortises were cut along the edges of the elements at the proper depth and position according to the new dimensions, allowing for optimal insertion of “biscuits” for reinforcement. The frame was reassembled, which involved applying bone glue followed by mechanical clamping (Figure 5c,d). This procedure restored the frame's structural integrity to a level superior to its initial state. The missing decorative elements were milled according to the original design and then attached to the frame using bone glue (Figure 6a).

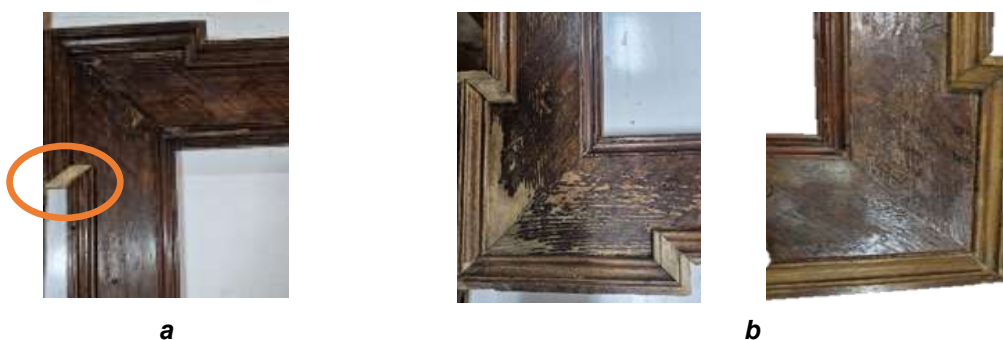
Fig. 6.

**Decorative element completing (a) and chromatic reintegration of the finishing layer - before and after (b).**

The controlled application by cotton swabs allowed for the gradual removal of dirt without damaging the original finish.

After confirming that the finishing layer was shellac, as evidenced by its solubility in ethanol, chromatic reintegration was carried out. The gaps were filled with a primer made from 3% fish glue, chalk powder, and yellow stain. Retouching was then performed using multiple translucent layers of tempera colors, and the final layer was sealed with an 11% shellac solution (Figure 6b). Finally, two coats of shellac were applied with a brush. The surface was then sanded with 320-grit abrasive paper and polished with a cloth pad.

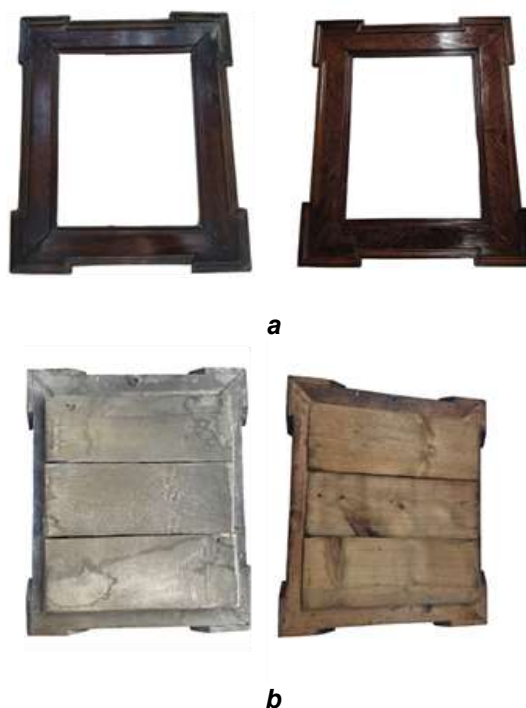
**Fig. 7.**

***Mirror frame before and after restoration: a- Front side; b- Back side.***

As a final preventive-conservation measure, all unfinished wooden areas, particularly at the back, were treated with insecticide-fungicide Proxilin primer.
