## CHALLENGES IN THE CONSERVATION OF AN EARLY 19<sup>th</sup> CENTURY HOLY DOOR - THE FIRST STEPS

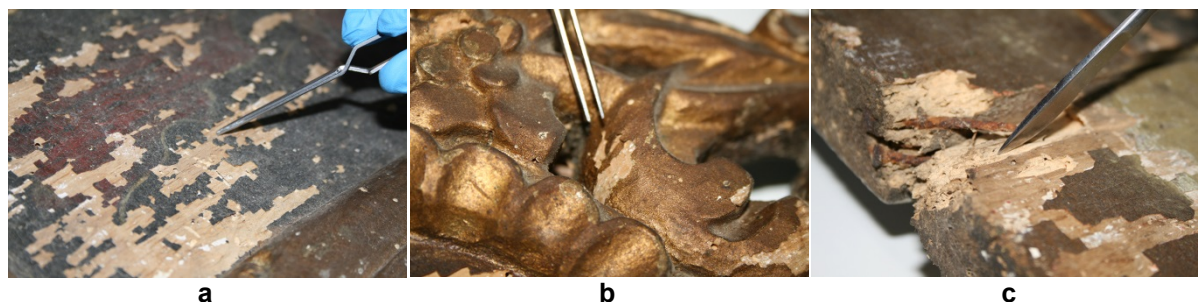
Fig. 3.

Before any direct intervention relevant photos were taken to document the initial state of conservation and the whole object was meticulously examined by naked eyes and through magnifying glasses. At this stage, small samples of painting layer (P1, P2, P3, P12/ icon I1: P4/ icon I4, P7/ icon I3), “gilding” and wood substrate (P11) were collected from damaged areas (Fig. 3) for investigations. Supplementary, samples of less degraded wood were collected from the back of the panels (L1) and rails (L2) for wood species investigation.

*Collection of samples for investigations: a) painting layer; b) gilding; c) frail wood.*
